# CONFIDENTIAL INSPECTION REPORT

## Sample 2

21 Creekside Drive  
Yourtown, PA 17000

# GENERAL INFORMATION

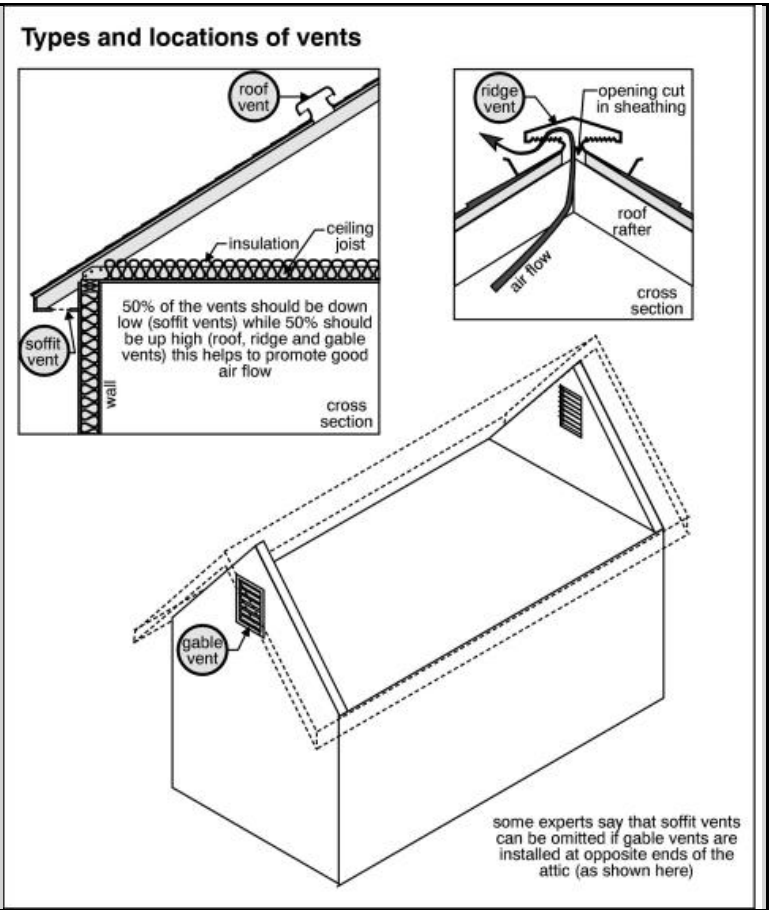
### ATTIC VENTILATION

Ridge and soffit vents noted.

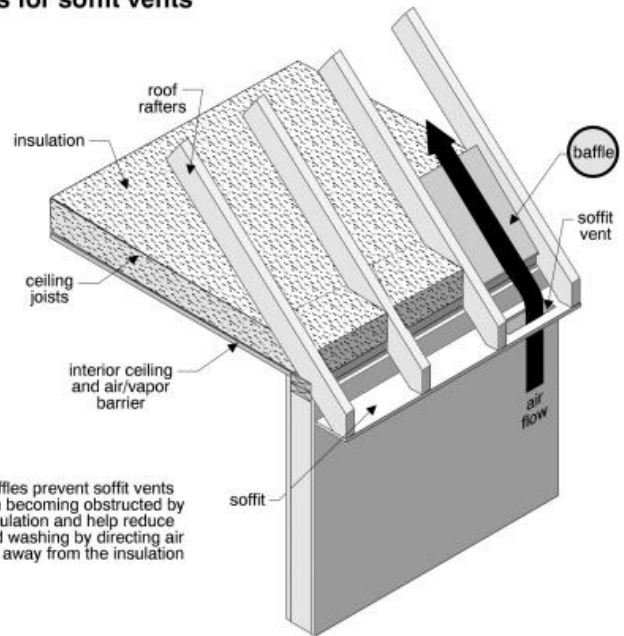
**Baffles for soffit vents**

baffles prevent soffit vents from becoming obstructed by insulation and help reduce wind washing by directing air flow away from the insulation

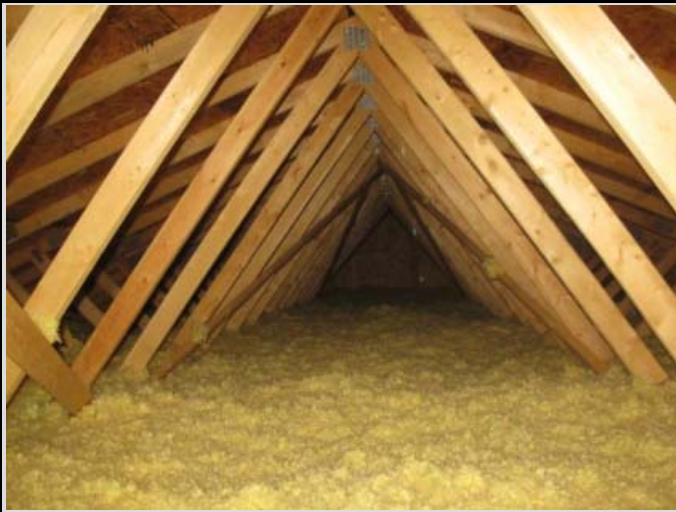
**DEPTH AND R-FACTOR:**

15-18 inches.

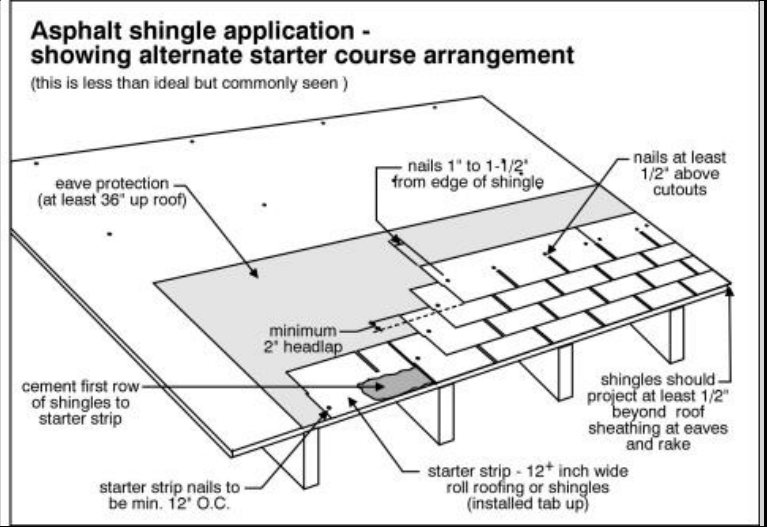
**TYPE:**

Composition shingles: Asphalt or fiberglass roofing shingles generally have service lives of 15-20 years and 20-25 years respectively in this area of the country. Heavy duty shingles will often last 25 to 30 years before replacement is needed. Early signs of aging include brittleness, minor curling, and loss of mineral granules, while signs of advanced aging are severe curling, broken or split shingles, and exposed felts. The useful life of a roof can be extended by patching and coating eroded or worn areas as they become evident. As a roof approaches the end of its economic life expectancy, patching becomes increasingly necessary, due to an increased likelihood of leakage in the last few years of roof life.

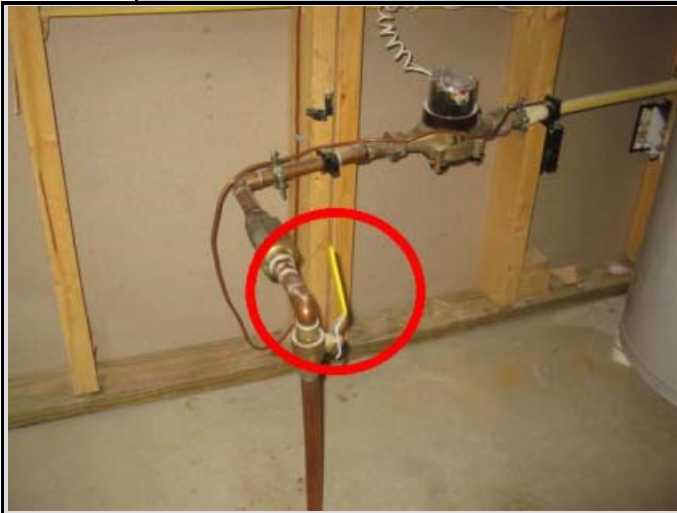
Main water shut off valve located in the basement ([Valve NOT tested](#))

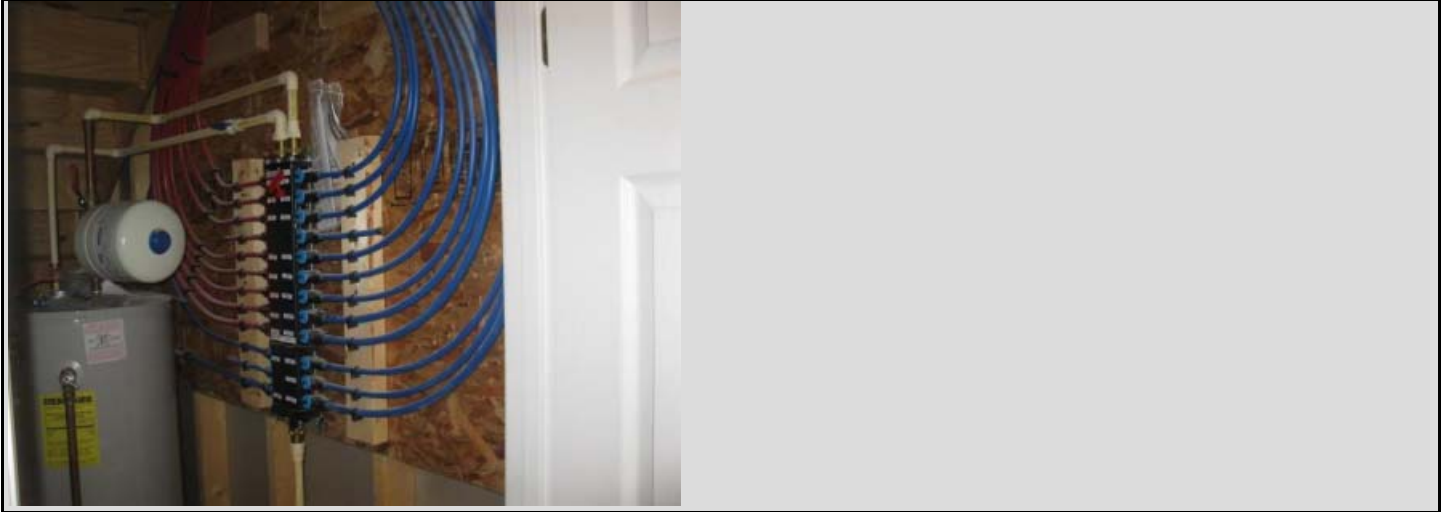
Plastic, [Maniblock system noted](#). Each water line is equipped with an independent shut off valve.

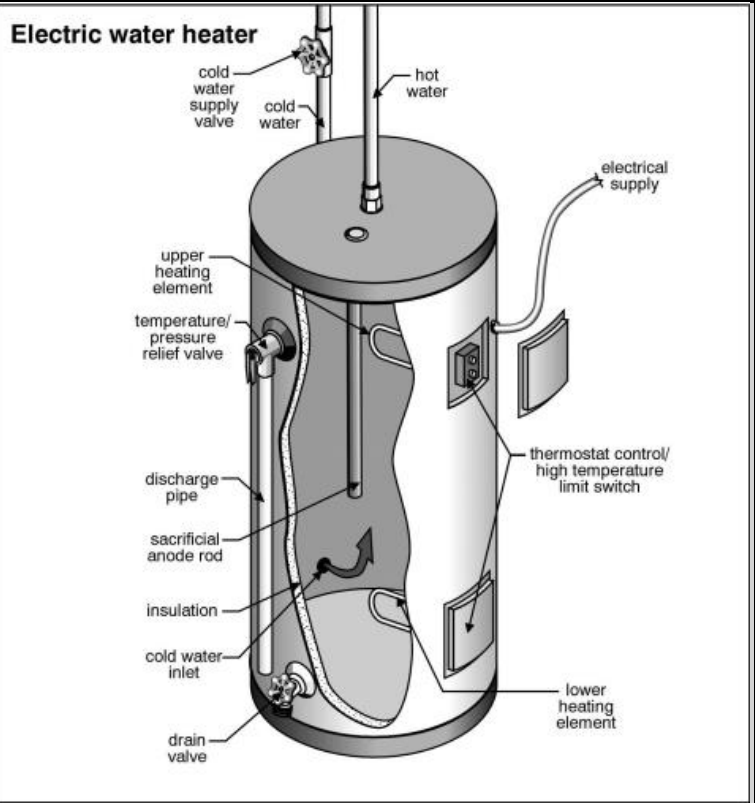
Electric.

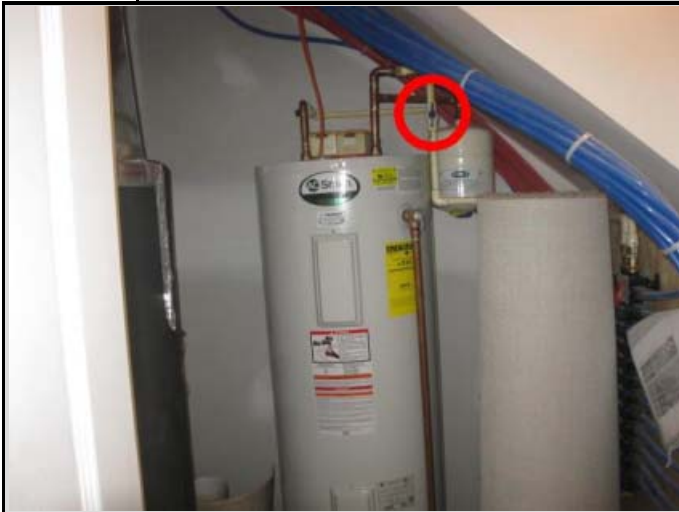
A water shutoff valve is installed, not tested.  
Pressure relief valve noted, not tested.

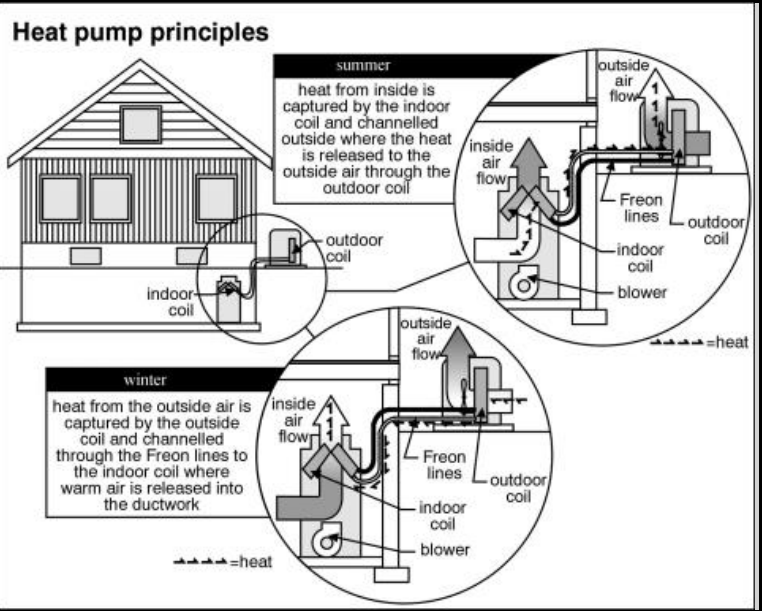
Forced Air: Maintenance or lack of maintenance will effect the service life of mechanical components. [Estimate Life expectancy of BURNERS: Gas fired 30 to 40 years. Oil fired 15 to 30 years.](#)

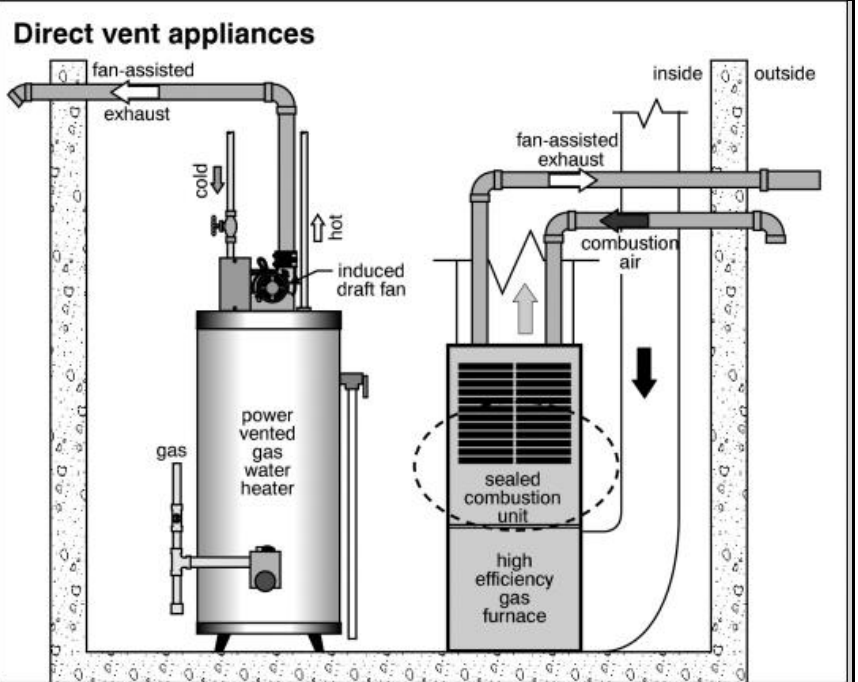
Appears serviceable, Heating plant is a direct vent system equipped with fan-assisted exhaust. No chimney required. exhausted is vented to the exterior via plastic or a metal pipe.

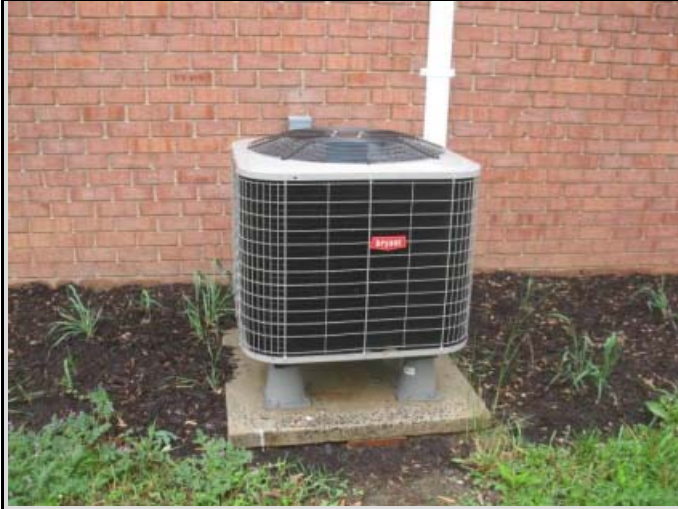
Central Air Conditioning.

Unit is not producing an adequate air temperature drop. AIR CONDITIONING SYSTEM NOT COOLING HOUSE: Air conditioning system was operational but did not cool the house sufficiently during the inspection. System did not produce the optimum air temperature drop of 15 to 23 degrees. Older units may not perform to this optimum, but should give at least 15 degrees of cooling. Suggest having a qualified air conditioning firm make further evaluation and repairs as needed prior to settlement.

Unit is not producing an adequate air temperature drop. **AIR CONDITIONING SYSTEM NOT COOLING HOUSE:** Air conditioning system was operational but did not cool the house sufficiently during the inspection. System did not produce the optimum air temperature drop of 15 to 23 degrees. Older units may not perform to this optimum, but should give at least 15 degrees of cooling. Suggest having a qualified air conditioning firm make further evaluation and repairs as needed prior to settlement.

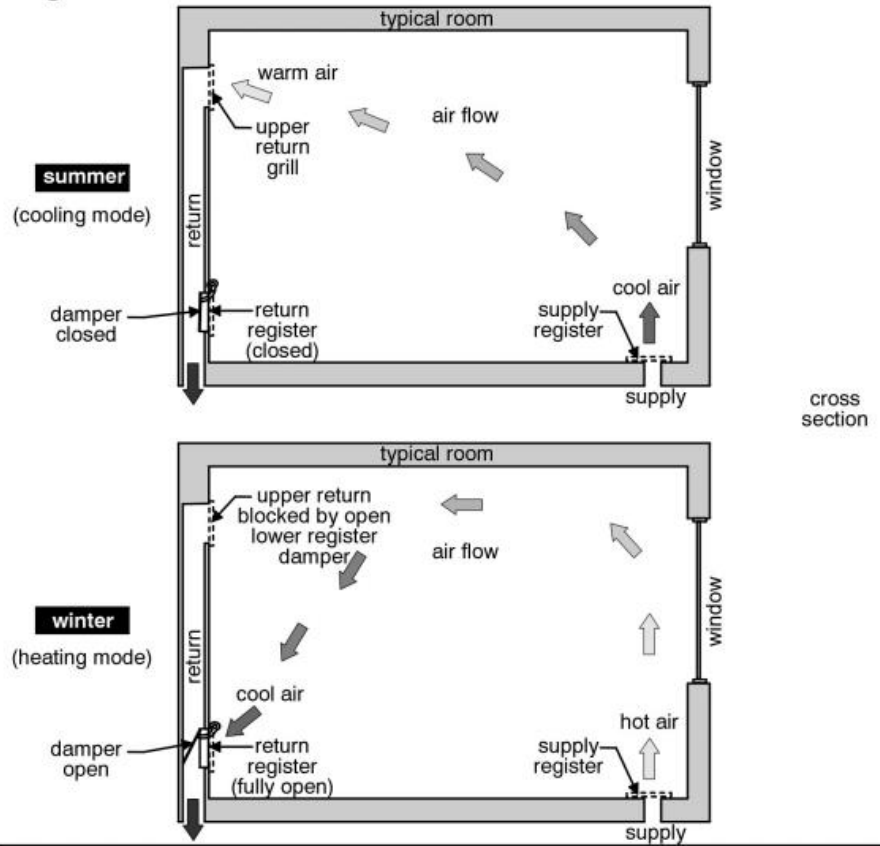
### High and low returns

Appears serviceable, **Both upper and lower return vent system noted.** Upper vents should be open in the summer and lower vents should be open in the winter. "SEE ILLUSTRATION"

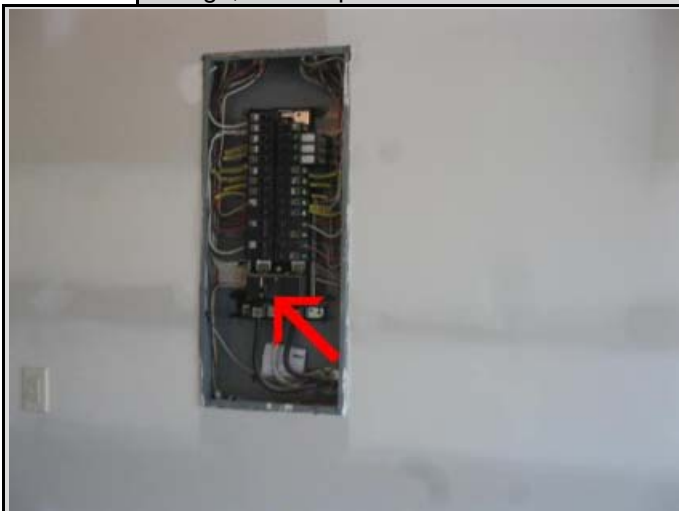
Garage, 200 Amp. Main breaker noted NOT tested. Appears serviceable.

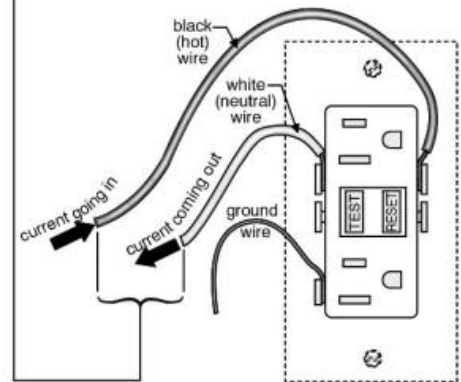
if there is a difference (even as little as 5 millamps), there is a current leak (possibly through your body) and the GFI shuts down the receptacle and other receptacles downstream

if the GFI is in the panel, the entire circuit will be shut down

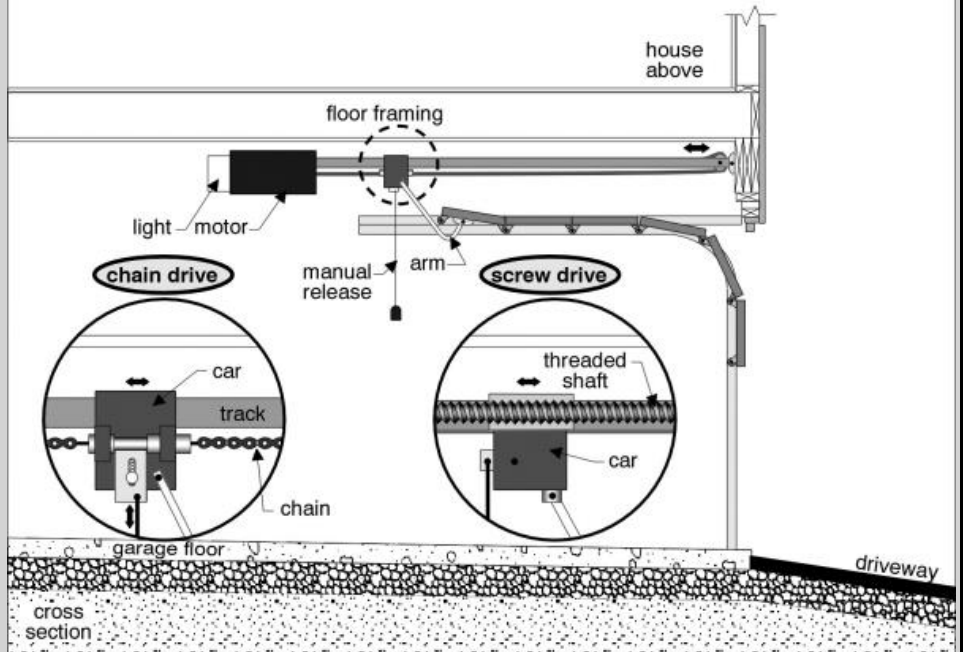
### Automatic garage door openers

Automatic door opener(s)-operational. Safety Sensor eyes operating properly. Automatic reverse feature is, **Not Fully operational.** Adjustment or service needed. **ADJUST AUTO-REVERSE SWITCH ON GARAGE DOOR: "Inspectors safety tip"** All overhead doors should have fully operational auto-reverse function to insure safe conditions. Most electric garage door openers now have an auto-reverse feature which acts to stop and reverse the door should some object (a child) be encountered while the door is closing. It is a safety protection device and its proper adjustment should not be neglected. Adjustment screws are generally labeled and within easy reach with a screwdriver. These mechanisms should be finely adjusted so they will reverse upon contacting something soft, such as a child. Use a basketball, placed in the path of the closing door to test this function and adjust as needed.

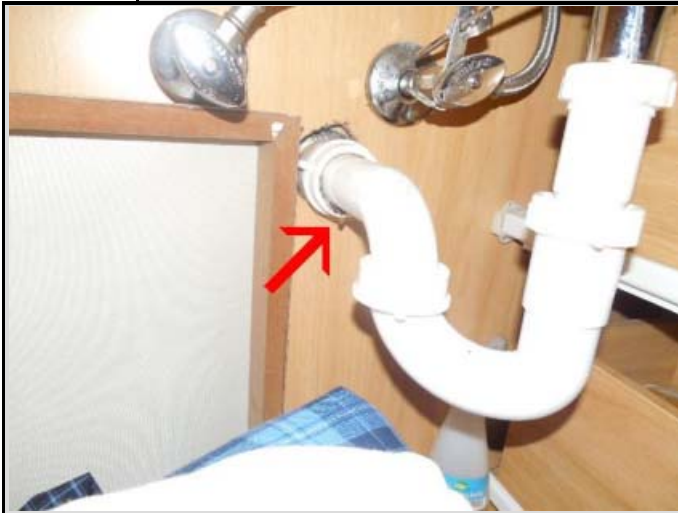
1. Leak noted at the drain. A licensed plumber should be called to make further evaluation and repairs as needed.

1. Leak noted at the drain. A licensed plumber should be called to make further evaluation and repairs as needed.
